# Optimized Methods of Cancer Detection via Optical Imaging with the Redox Scanner

Jennifer Geinzer  
SUNFEST 2003

# Goals

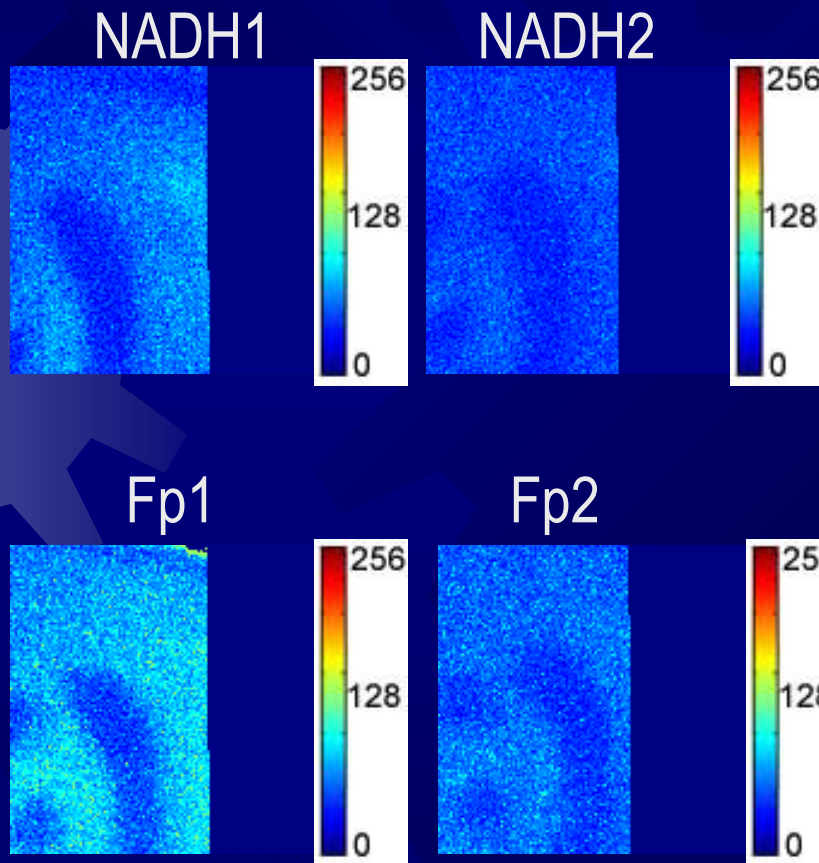
# High Signal Attenuation/Noise

- Standard-smiley face drawn on bright white paper with black marker
- Observed pixellation and low signal to noise ratio (white paper should show reflectance signal in red)
- Hypothesis wrong: S2 better than S1--probably not correct
- More calibration needed before able to compare different sources
- Source / detector optics not optimal

Initial test results of S1 & S2 indicate low signal-to-noise ratio

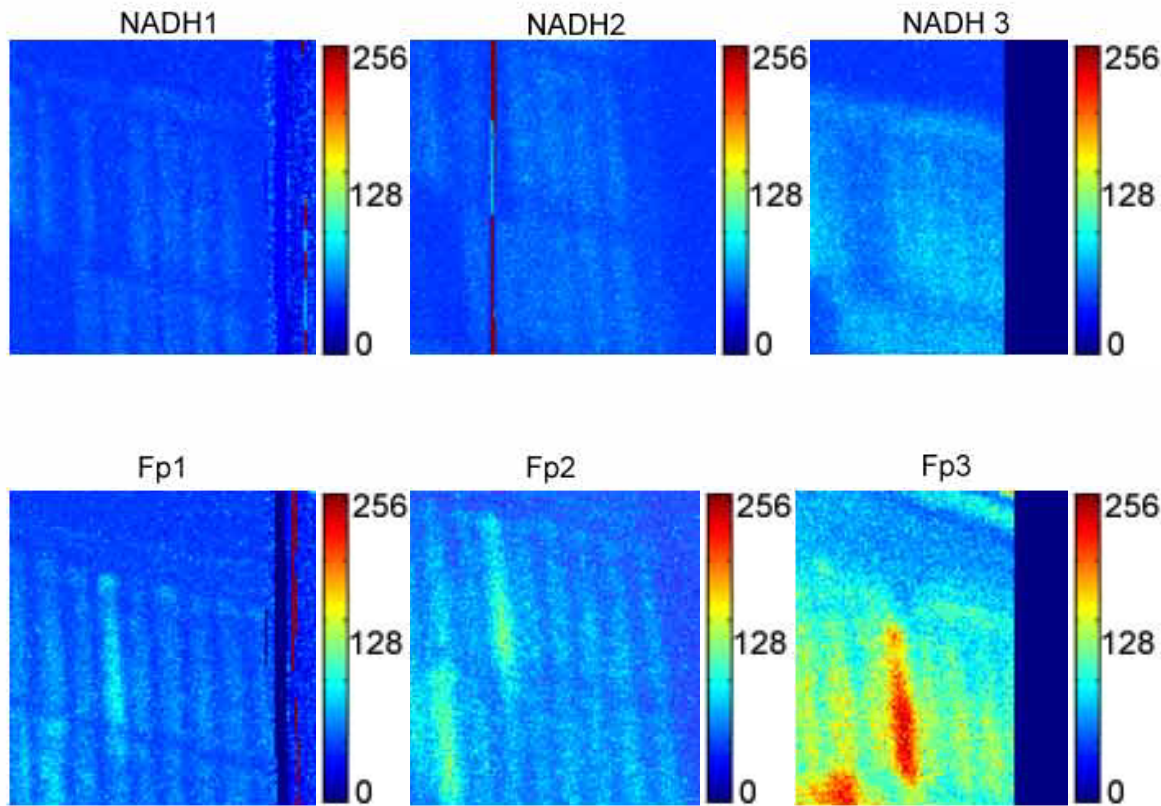
# Windows Timing Delay

- ☀ Standard-grid in black ink on white paper with yellow highlighter
- ☀ Data shifted down during each scan to right

Test results indicate the images are displayed incorrectly, caused by Windows timing inconsistencies
